# ENGLISH CATHEDRAL CARPENTRY

CECIL HEWETT

Illustrating his text with more than 160 magnificent line drawings, Mr. Hewett describes the carpenters' work that still survives in English cathedrals. He devotes chapters to ridged main-span roofs, lean-to roofs, apse roofs, polygonal chapter house roofs, doors and the few surviving windlasses and capstans that hoisted materials during building. Each chapter contains an outline of the broad course of development, the examples being placed in chronological order. In the appendix the author lists the carpentered contents of each cathedral and includes in the specialist glossary definitions of timber joints referred to in the text.

# CONTENTS

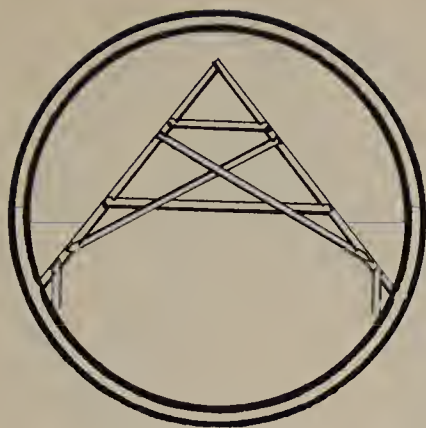
Fig. 95  
Scissor-braced examples

*Peterborough.* Seven couples over North West portico, found by R. Reuter to fit nave if hypothetically completed, and ?c. 1175.

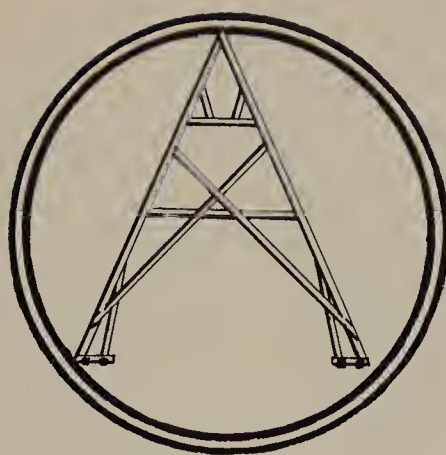
*Lincoln.* North choir transept high-roof, choir and transept dated: 1192-1200. Open notch-lapped scissors.

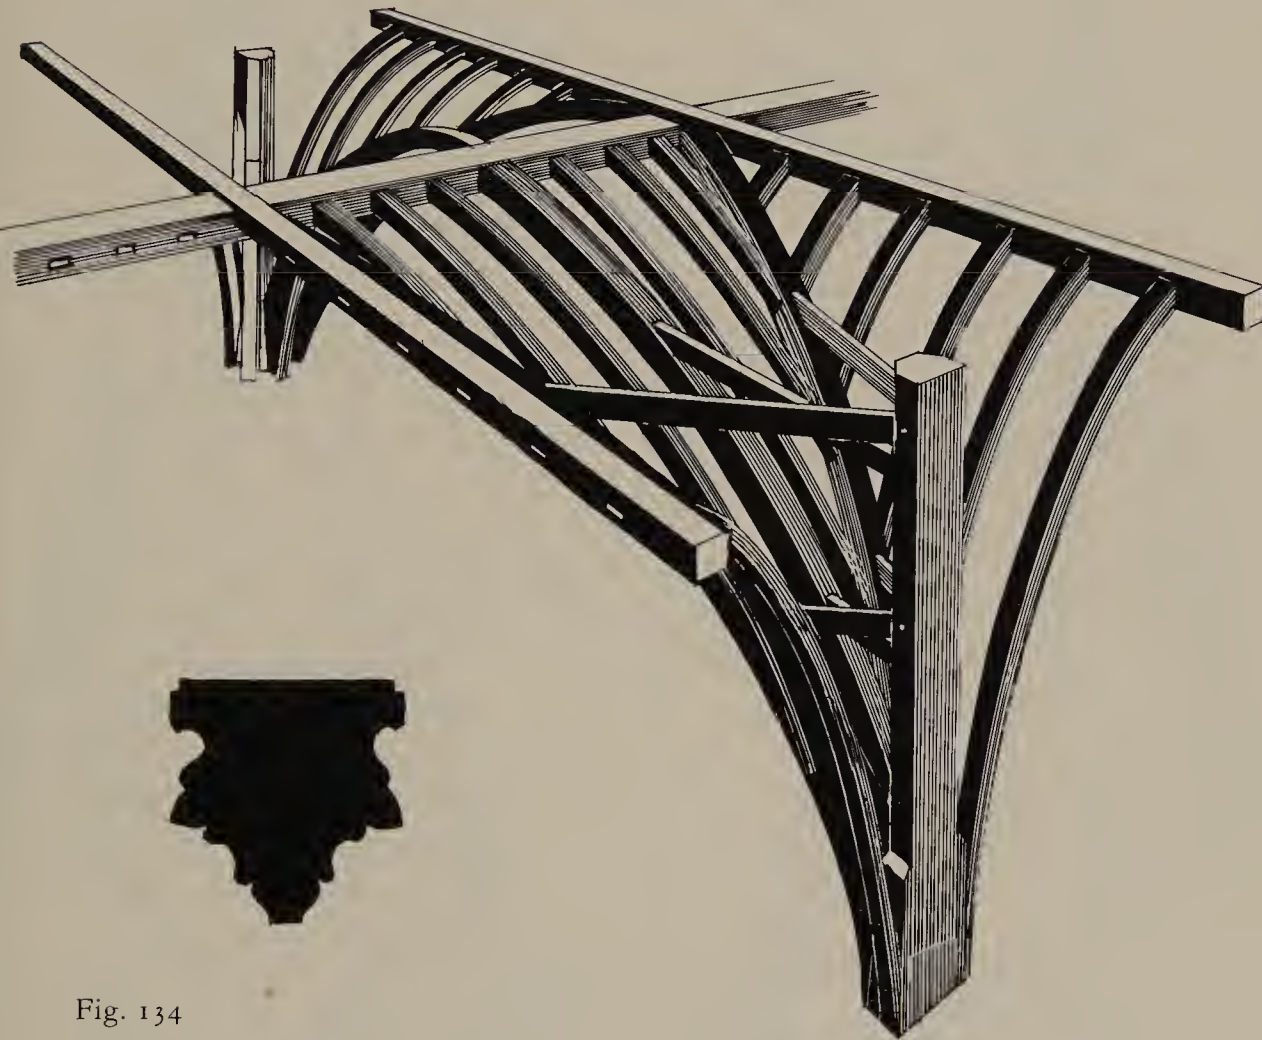
Fig. 134

The Abbot's Door is described on page 98. The timber vault of the presbytery is the oldest of the kind in England and is shown in Fig. 134, together with the profile of its rib-timbers. This is diagonally supported from posts that formerly might have been components of the high roof, now missing. The whole was sensitively restored and would repay exhaustive study.
